NDE METHOD FOR CHARACTERIZING ANODIZED A1 SURFACES

ROCKWELL INTERNATIONAL SCIENCE CENTER
1049 CAMINO DOS RIOS
THOUSAND OAKS, CALIFORNIA 91360

TECHNICAL REPORT AFML-TR-78-146
Final Report for period 1 September 1977 through 31 July 1978

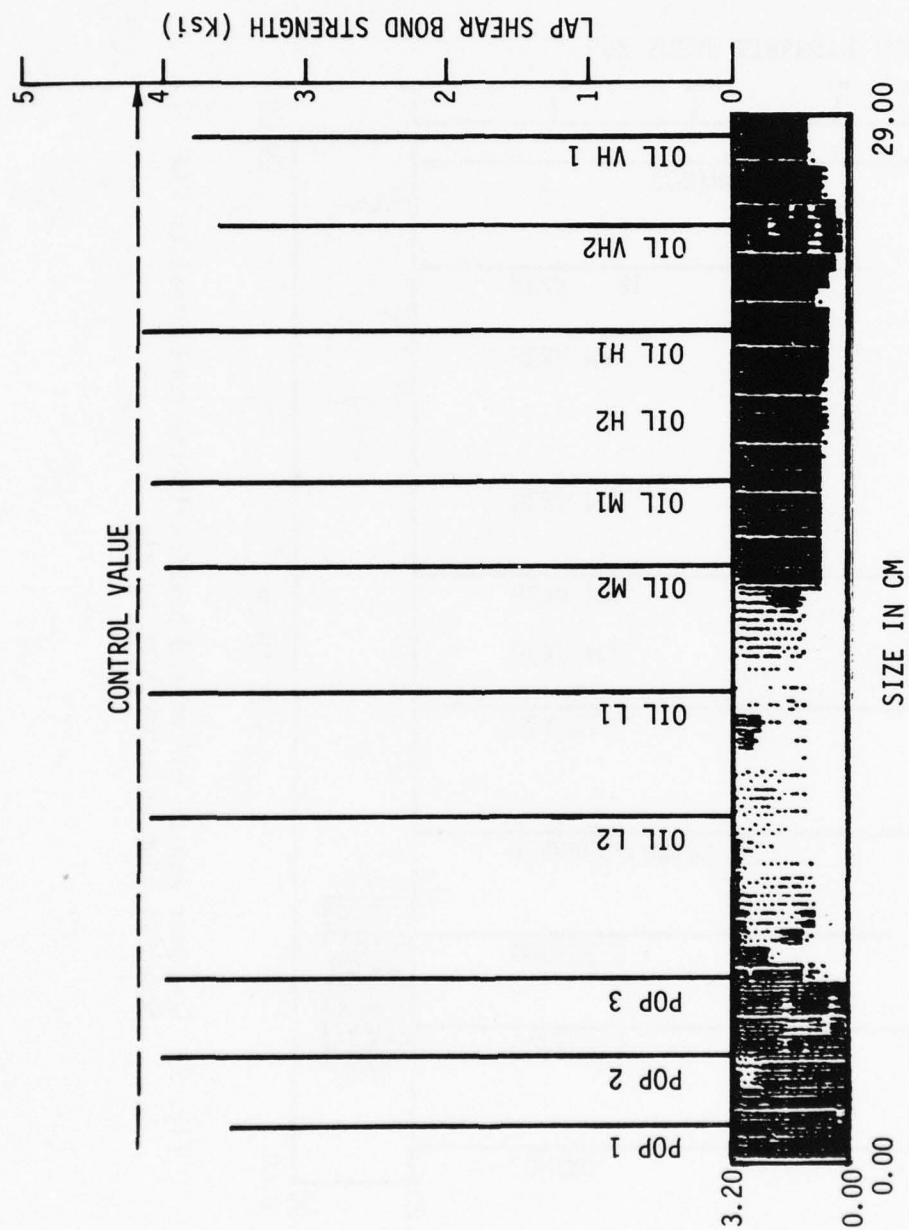
Fig. 21 Computer map of oil and soda pop (Coca Cola) contamination on PAA
 A1 7075-T6 production panel from McDonnell-Douglas.

One square foot production panels were anodized at McDonnell Douglas. These panels were contaminated to varying levels along a 1 inch strip across the center of the panel and mapped. Table 31 gives results of this test. The table gives the type of contamination, the level L (Low), M (medium), H (high), VH (very high), the corresponding map figure number, the average water contact angle θ_{H_2O} , the lap shear strength and the percent interfacial failure. The corresponding maps and relative bond strength bar graphs are presented in Figs. 21 to 28.

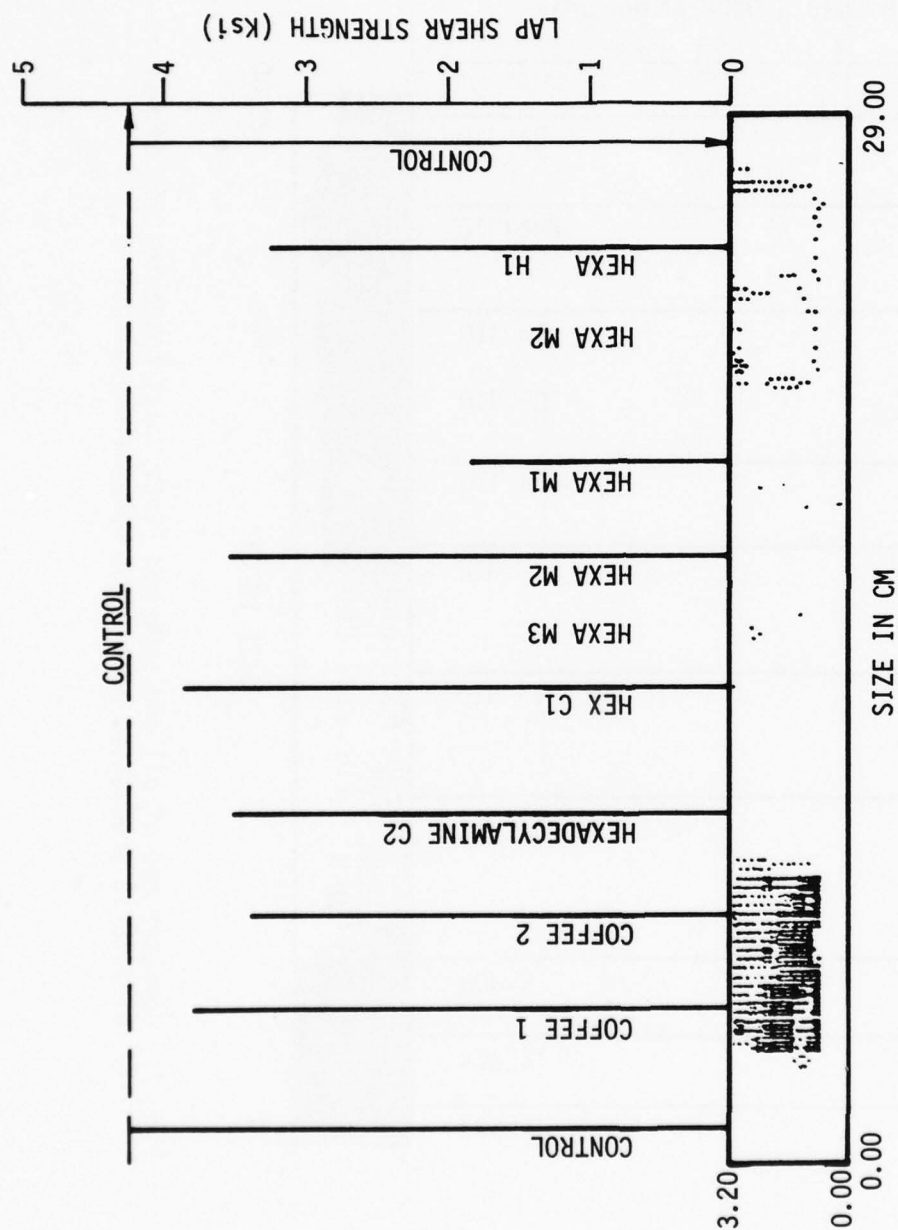
Fig. 22 Computer map of coffee and hexadecylamine contamination PAA McDonnell-Douglas production panel.

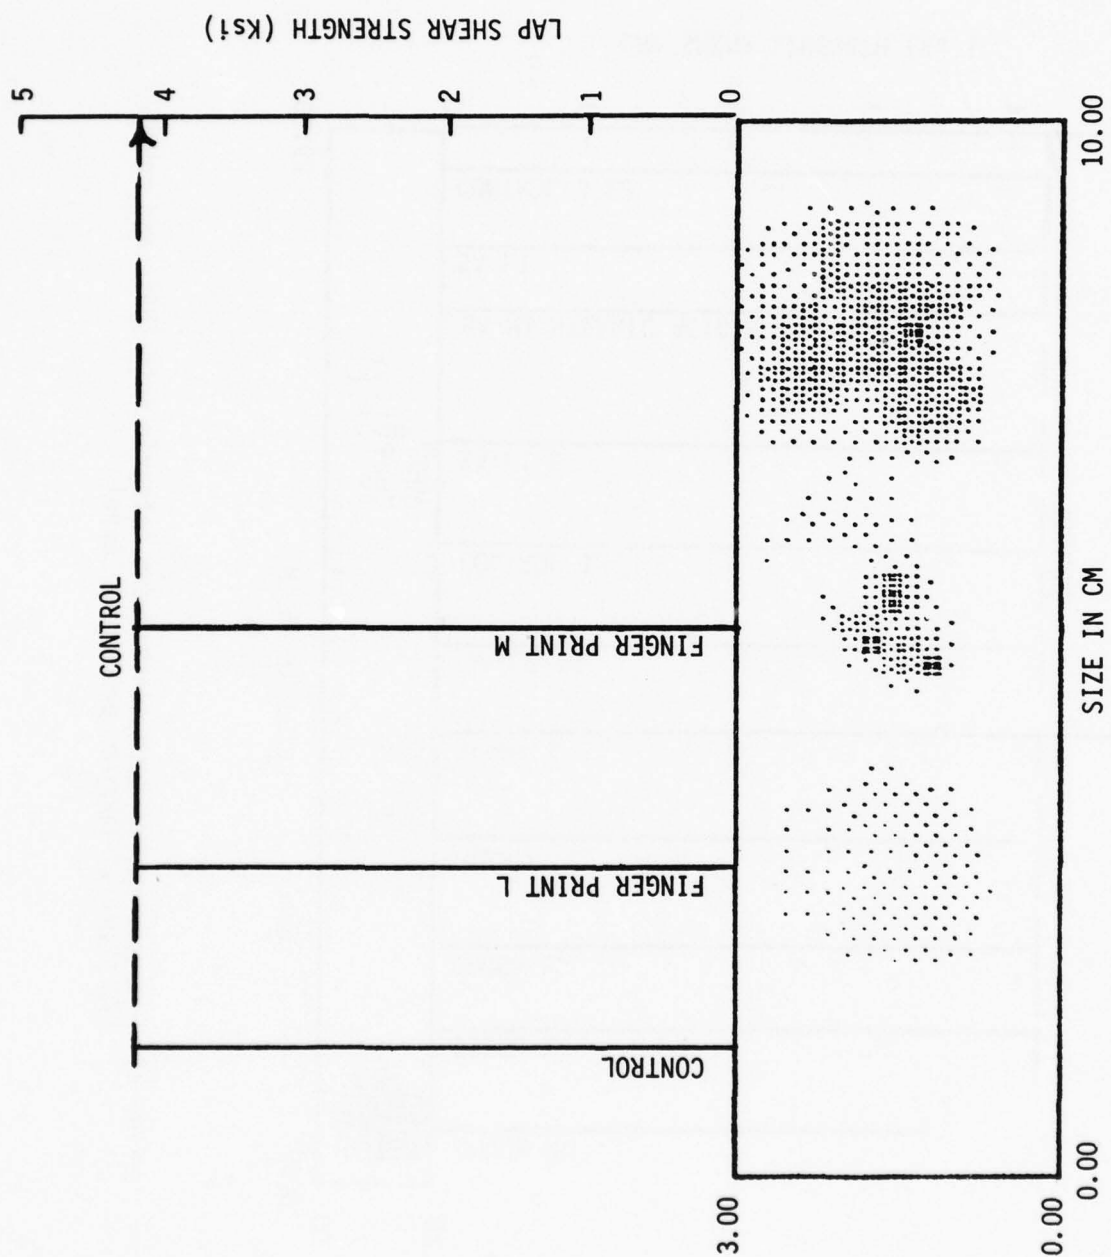
Fig. 23 Computer map of finger print contamination. PAA McDonnell-Douglas production panel.

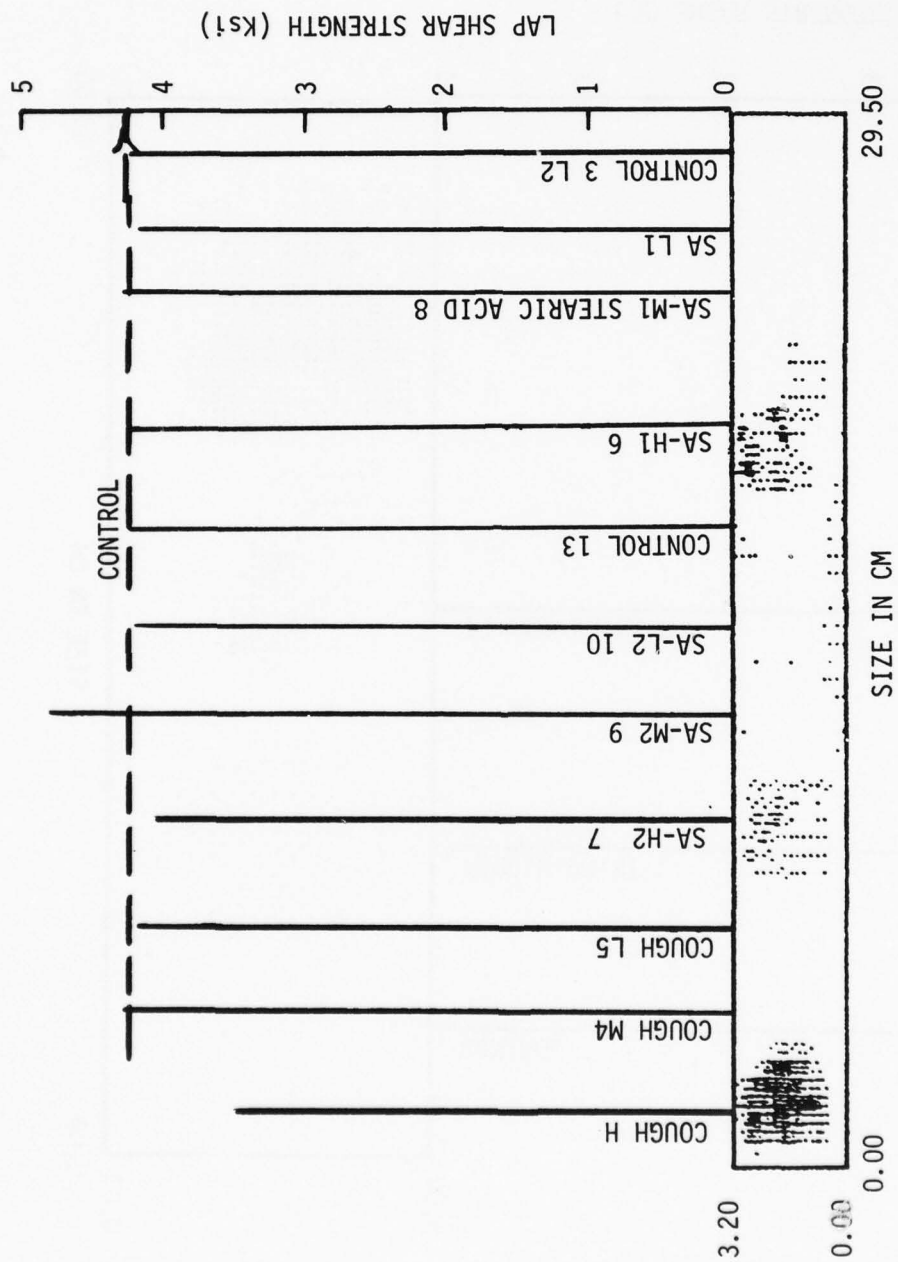
Fig. 24 Computer map of smog constituent (stearic acid (SA)) and cough.
PAA McDonnell-Douglas production panel

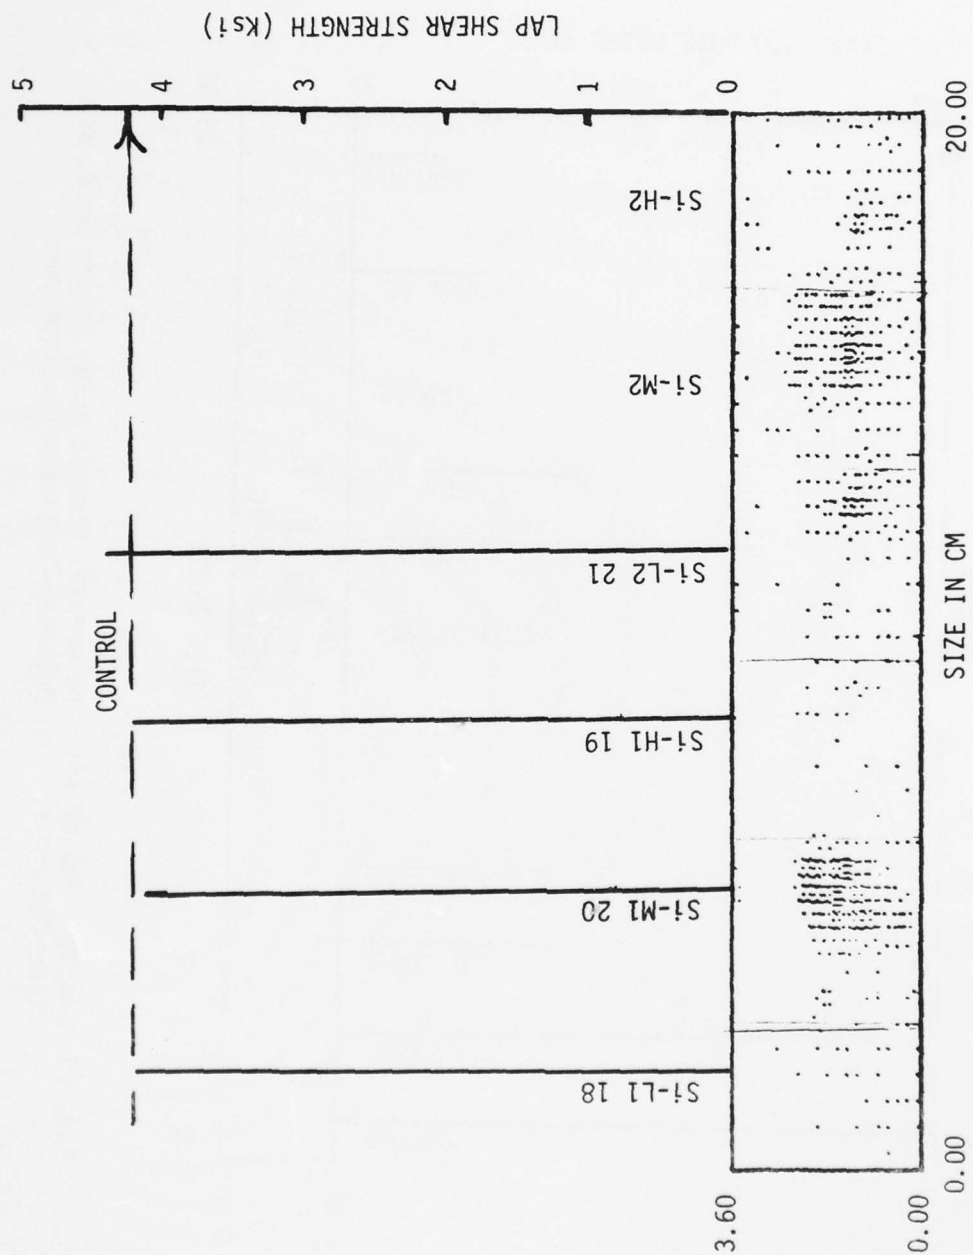
Fig. 25 Computer map of silicone grease contamination. PAA McDonnell-Douglas production panel.

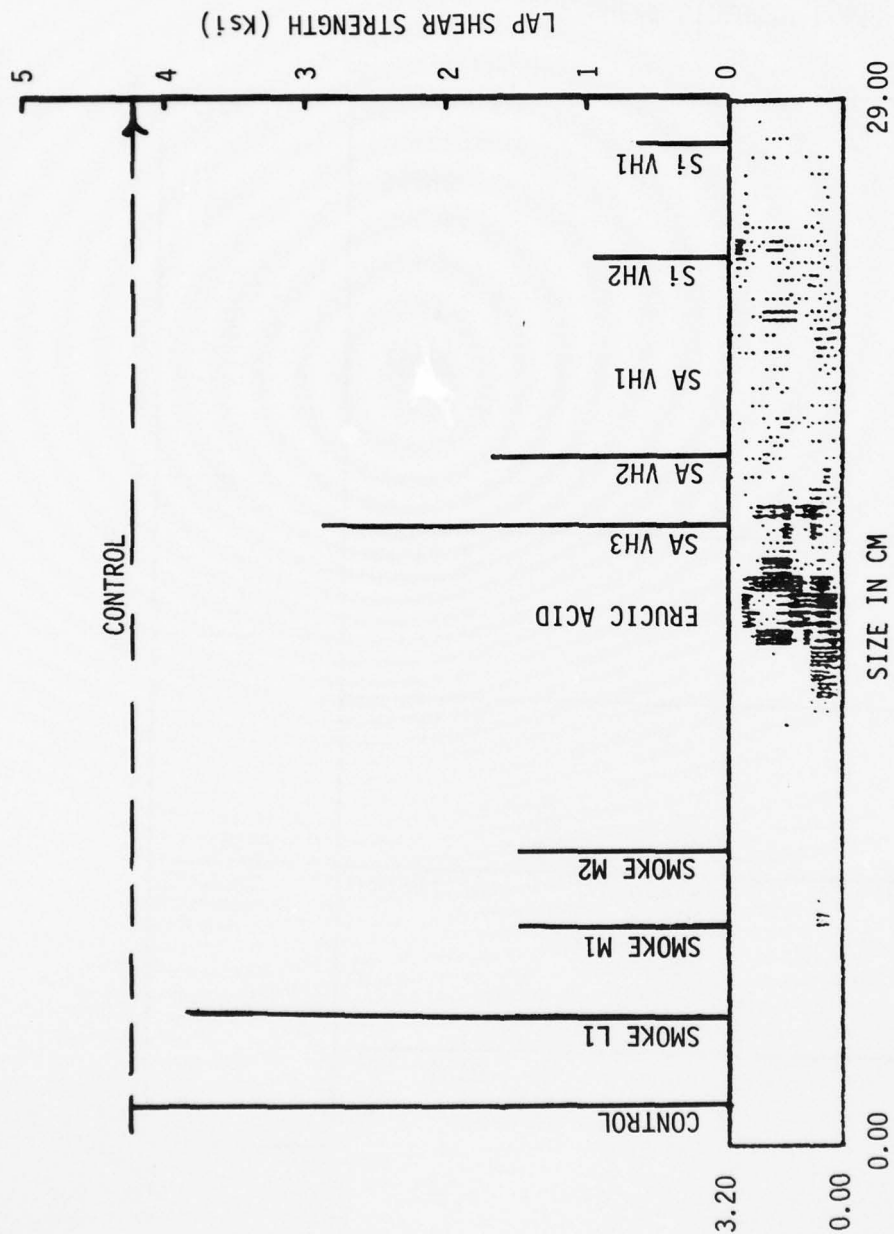
Fig. 26 Computer map of silicone grease, stearic acid, erucic acid, and cigarette smoke. PAA McDonnell-Douglas production panel.

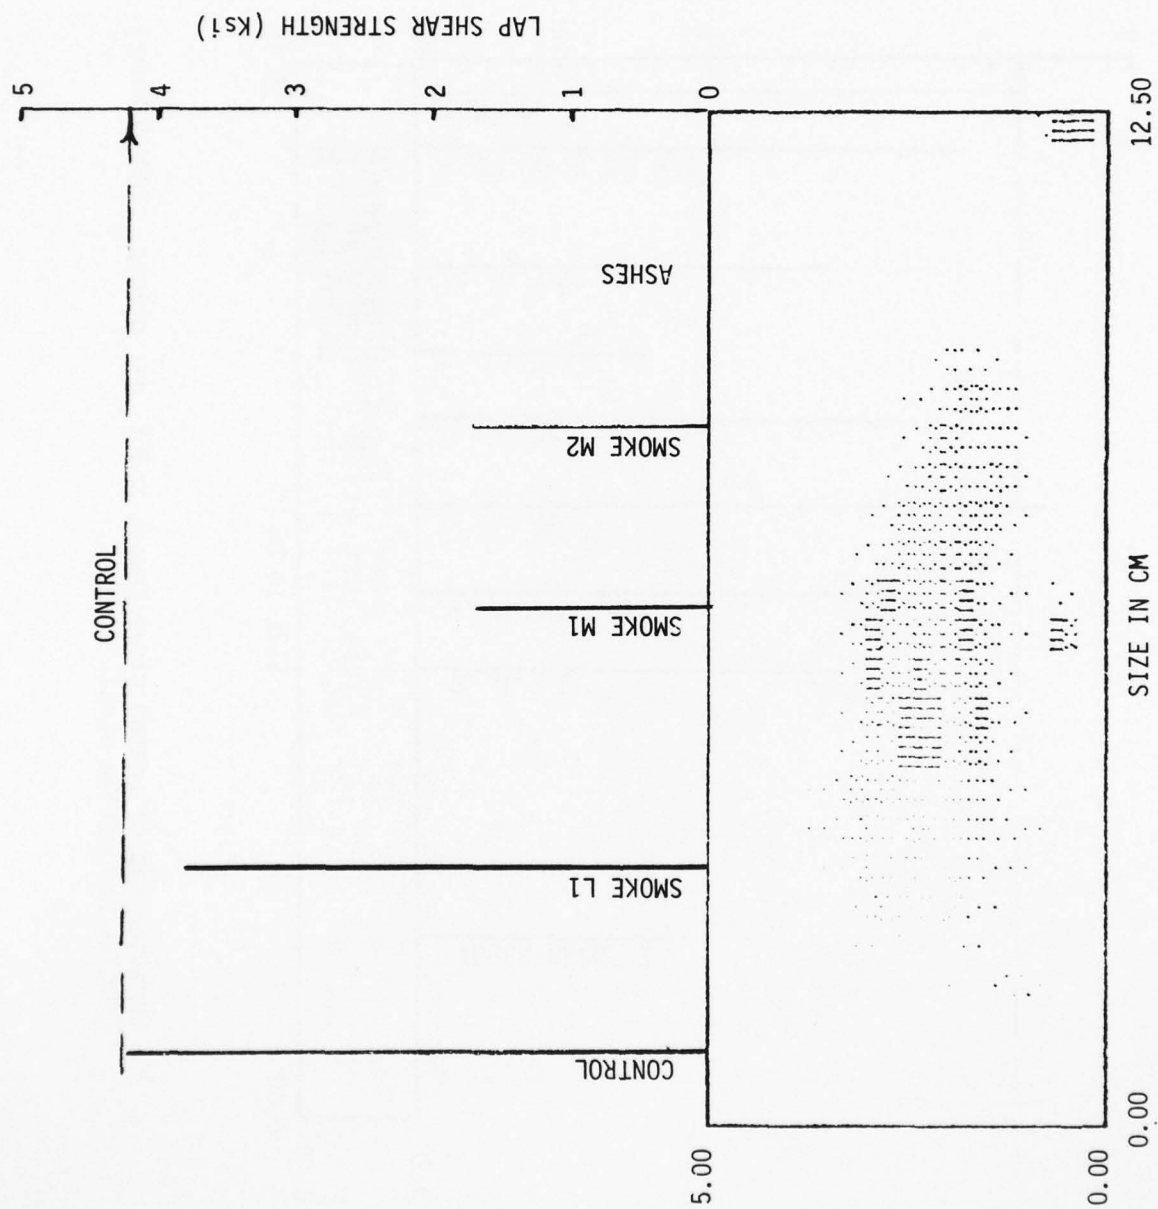
Fig. 27 Expanded computer map of cigarette smoke contamination area. PAA Mc-Donnell-Douglas production panel.

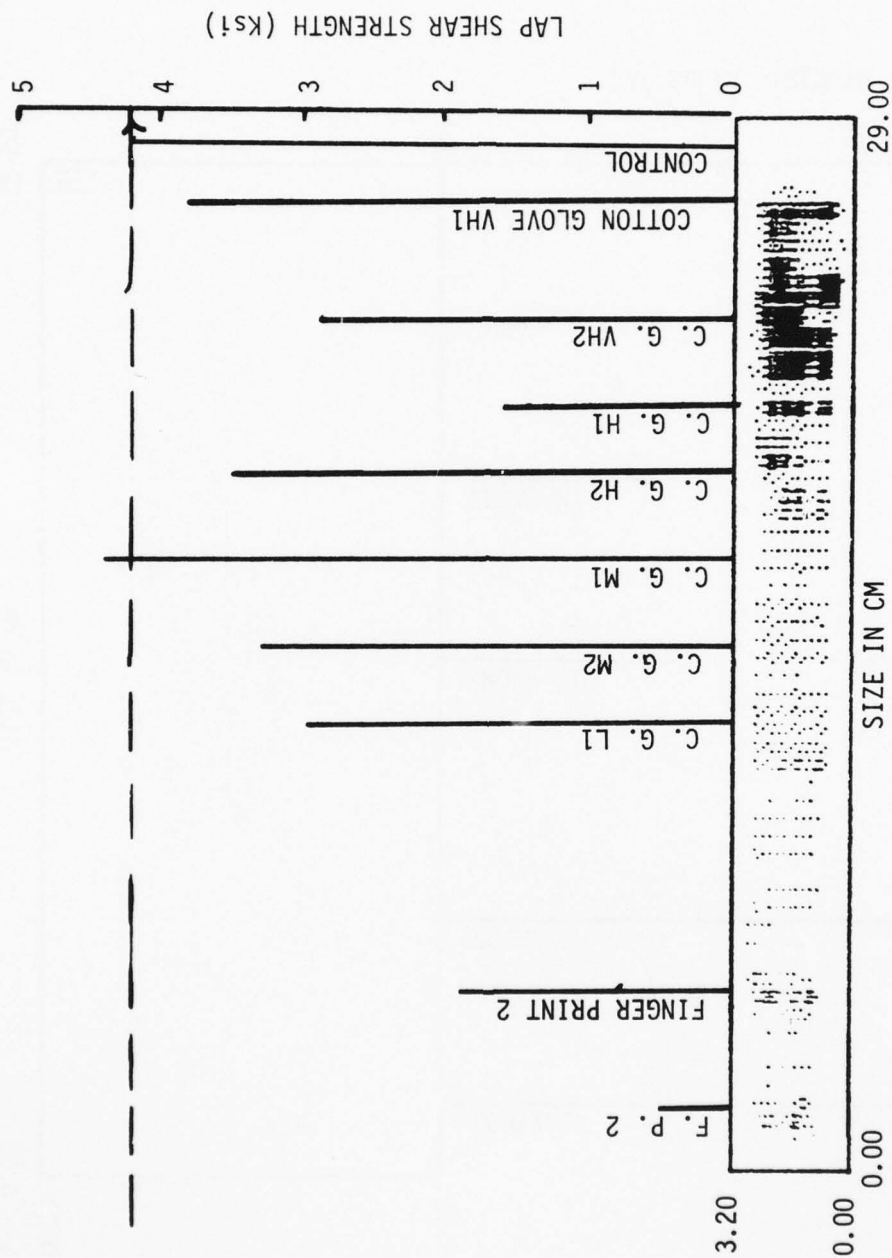
Fig. 28 Computer map of cotton glove smudge and finger prints. PAA McDonnell-Douglas production panel.

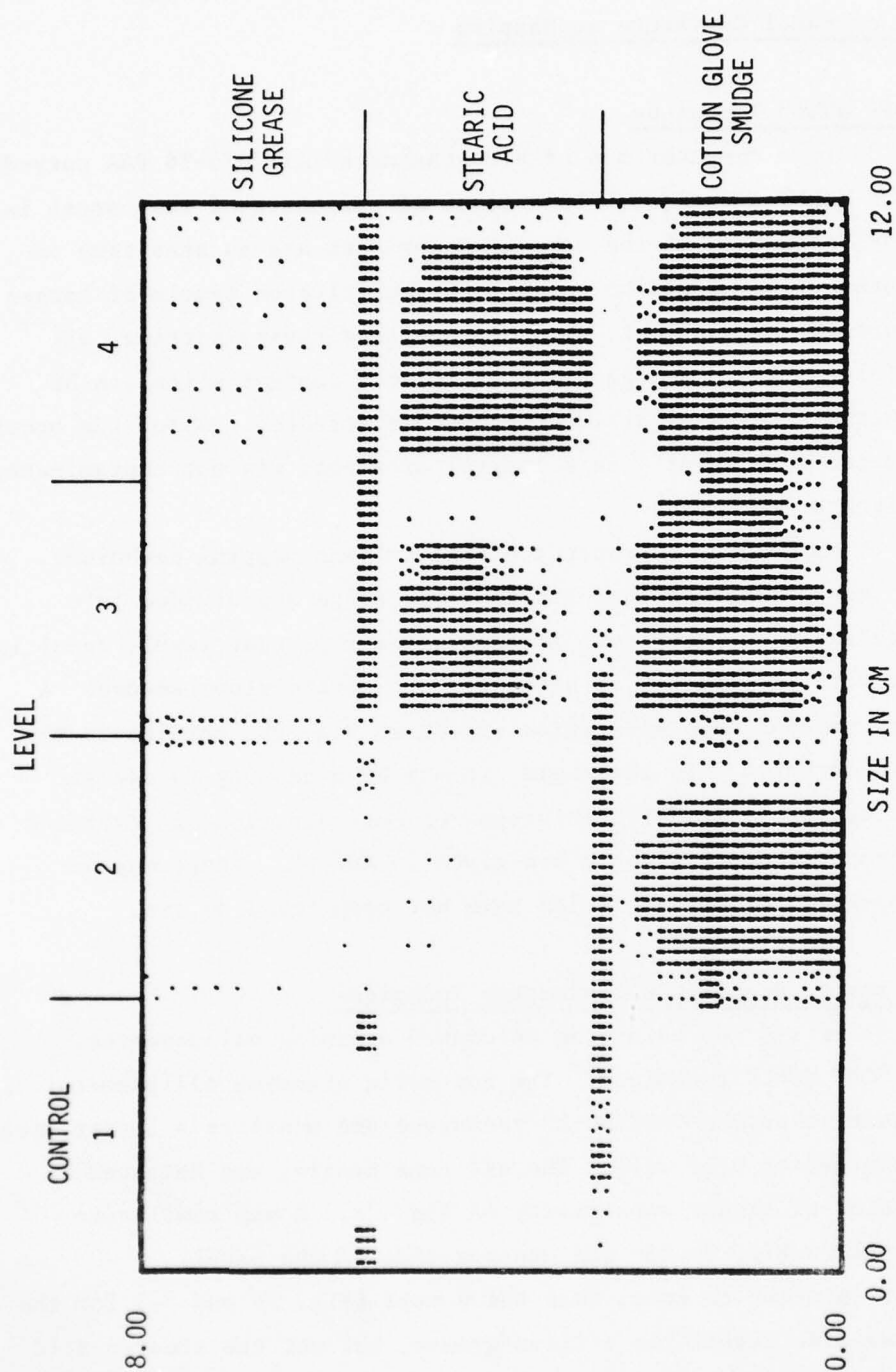
Fig. 29 Computer map of control (clean) and three levels of silicone grease, stearic acid and cotton glove smudge on a PAA AL 7075-T6 curved panel. Convex side by the Off Null technique.

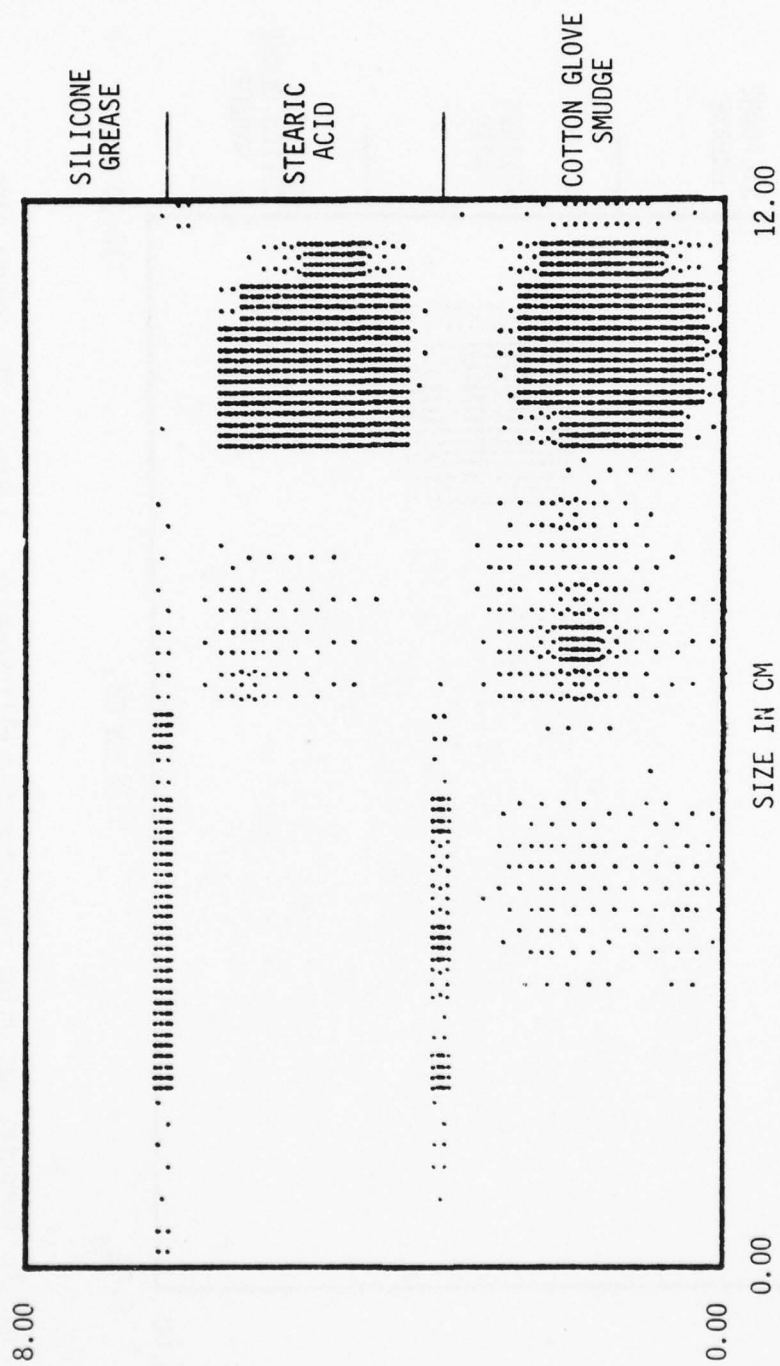
Fig. 30 Computer map at lower sensitivity than Fig. 29.

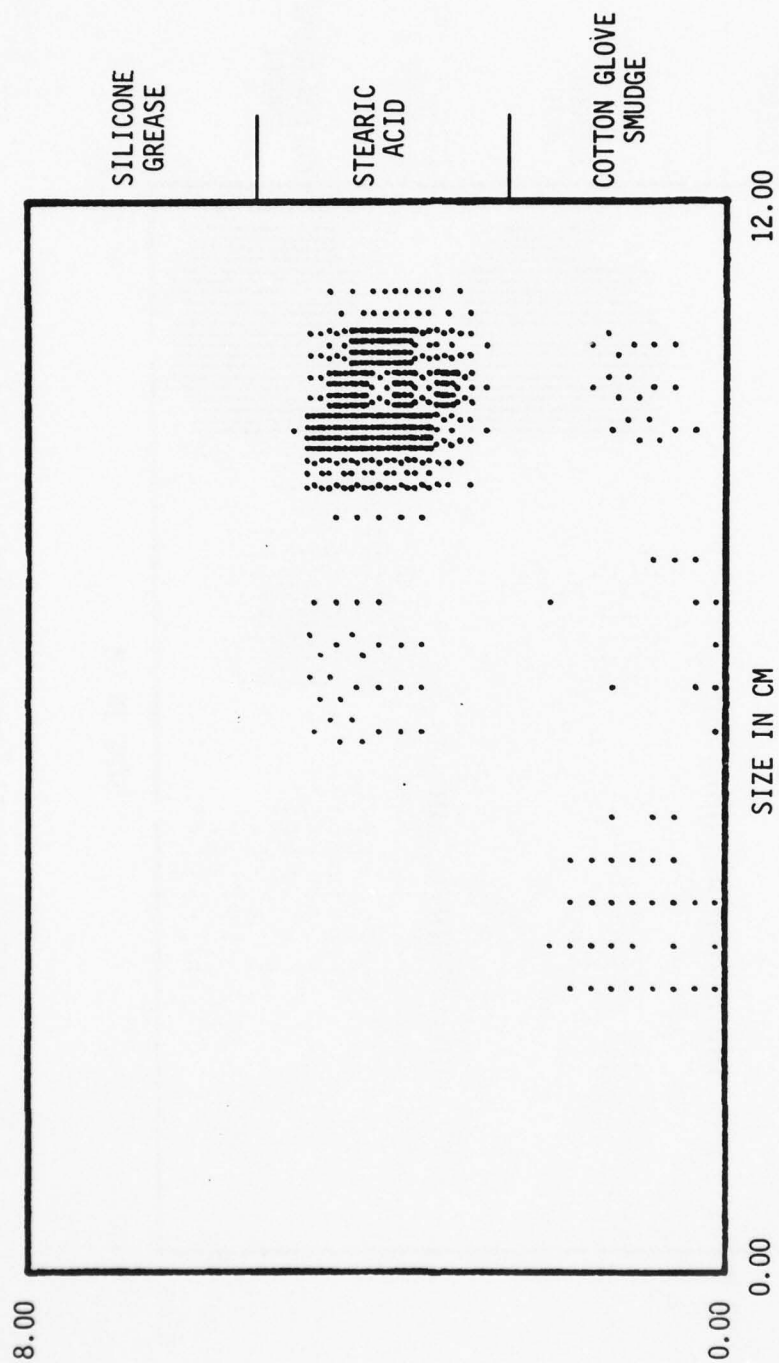
Fig. 31 Computer map using the automated ellipsometer. Δ map on the convex side.

Figure 31 is a Δ map using the automated scanning ellipsometer, rather than the "OFF NULL" technique. The automatic scanning ellipsometer is not quite as sensitive as the "OFF NULL" technique and monitors a larger area, but reveals contamination very well. The silicone grease, not detected in Fig. 31, is revealed at higher sensitivity in Fig. 32. A map similar to Fig. 31 is obtained in Fig. 33 for the concave side of the panel.

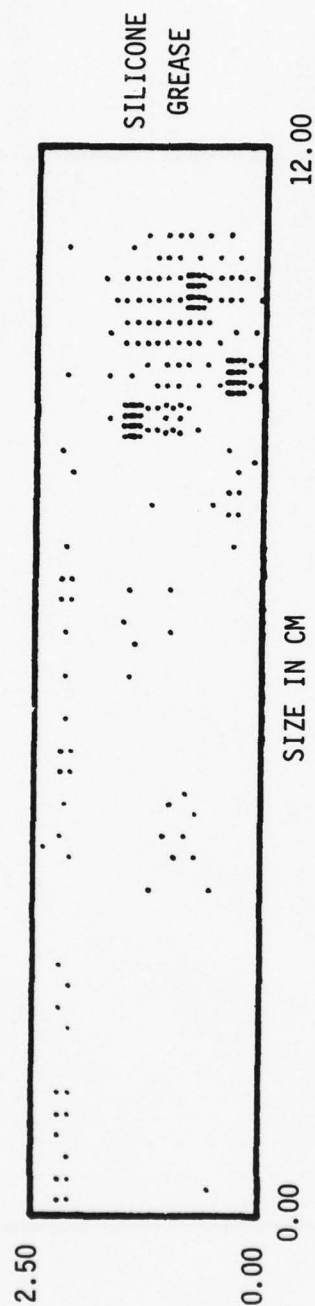
Fig. 32 Computer map using the automated ellipsometer in the silicone grease region. Δ plot of convex side with higher sensitivity.

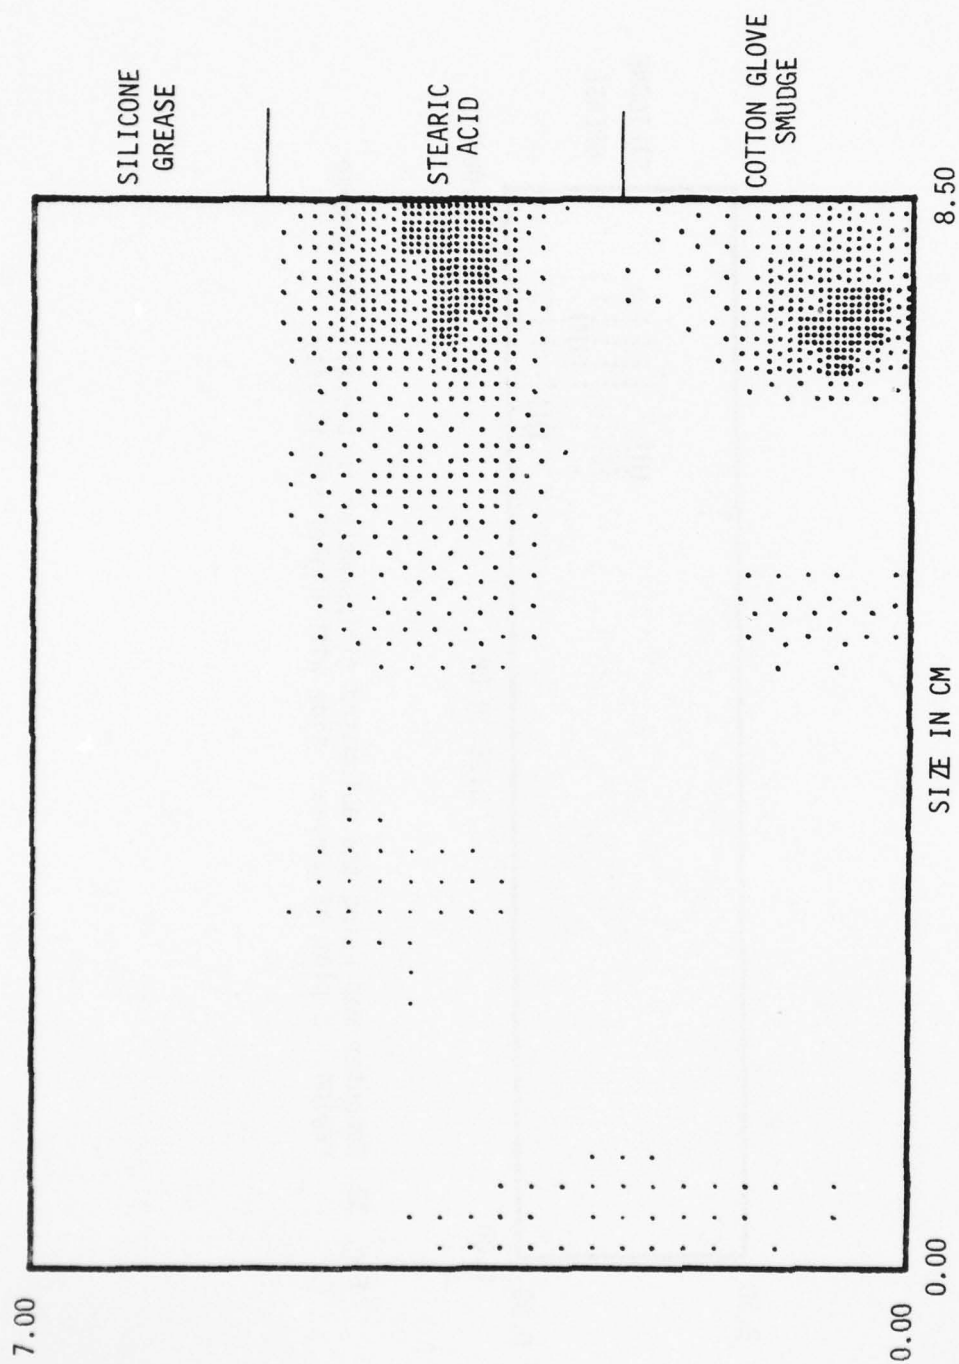
Fig. 33 Computer map using the automated ellipsometer rather than the Off Null technique. Δ plot on concave side.

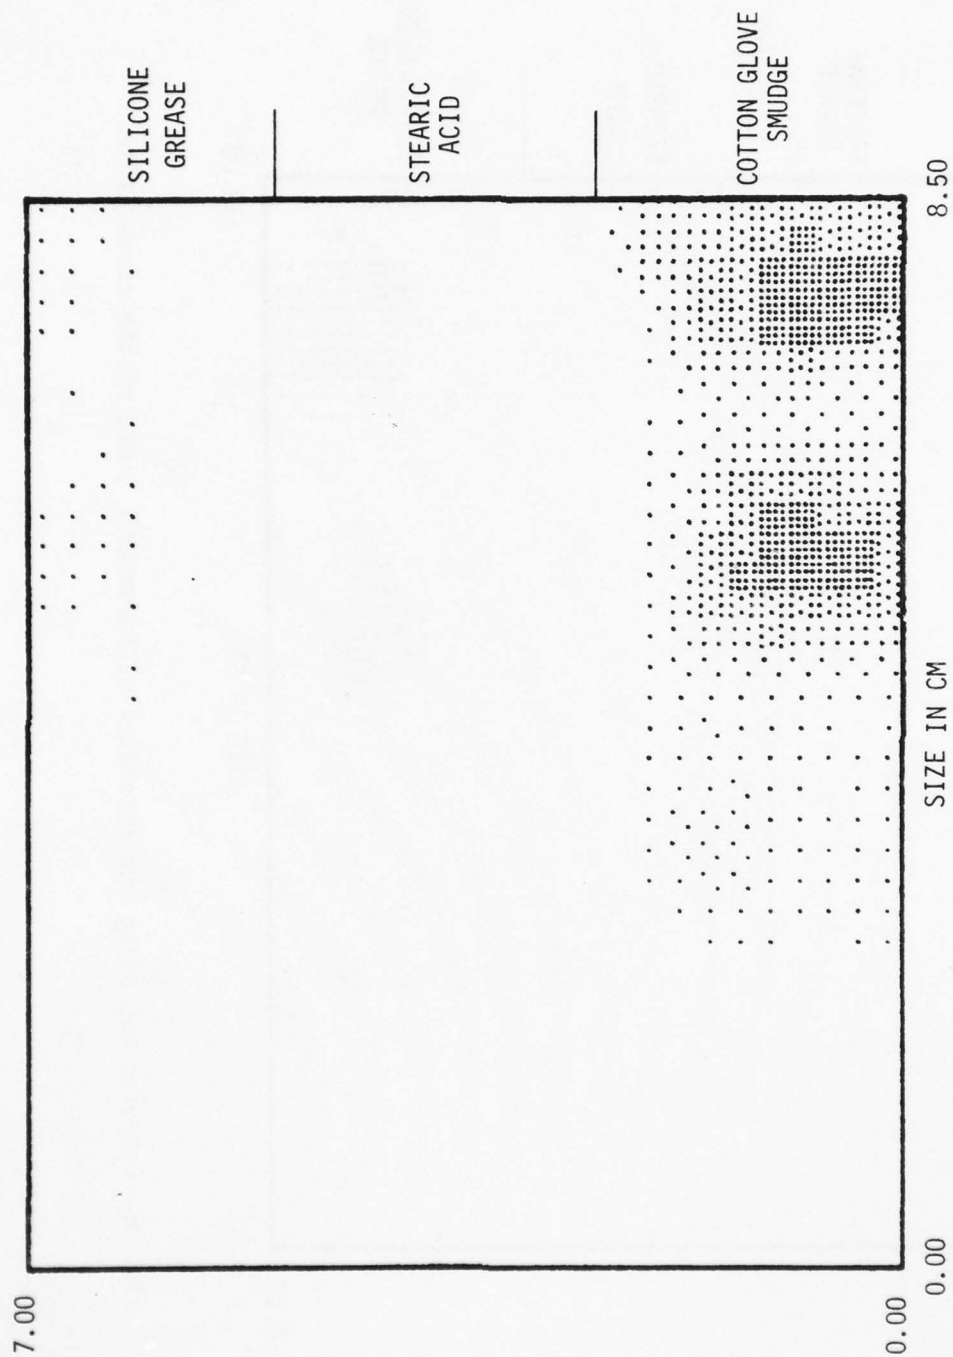
Fig. 34 Computer map using the automated ellipsometric ψ plot on concave side.

It is of interest to note, that the ψ maps (Fig. 34 and 35) for the concave and convex side reveal the silicon grease, but not the stearic acid. Both Δ and ψ maps reveal cotton glove smudge very well.

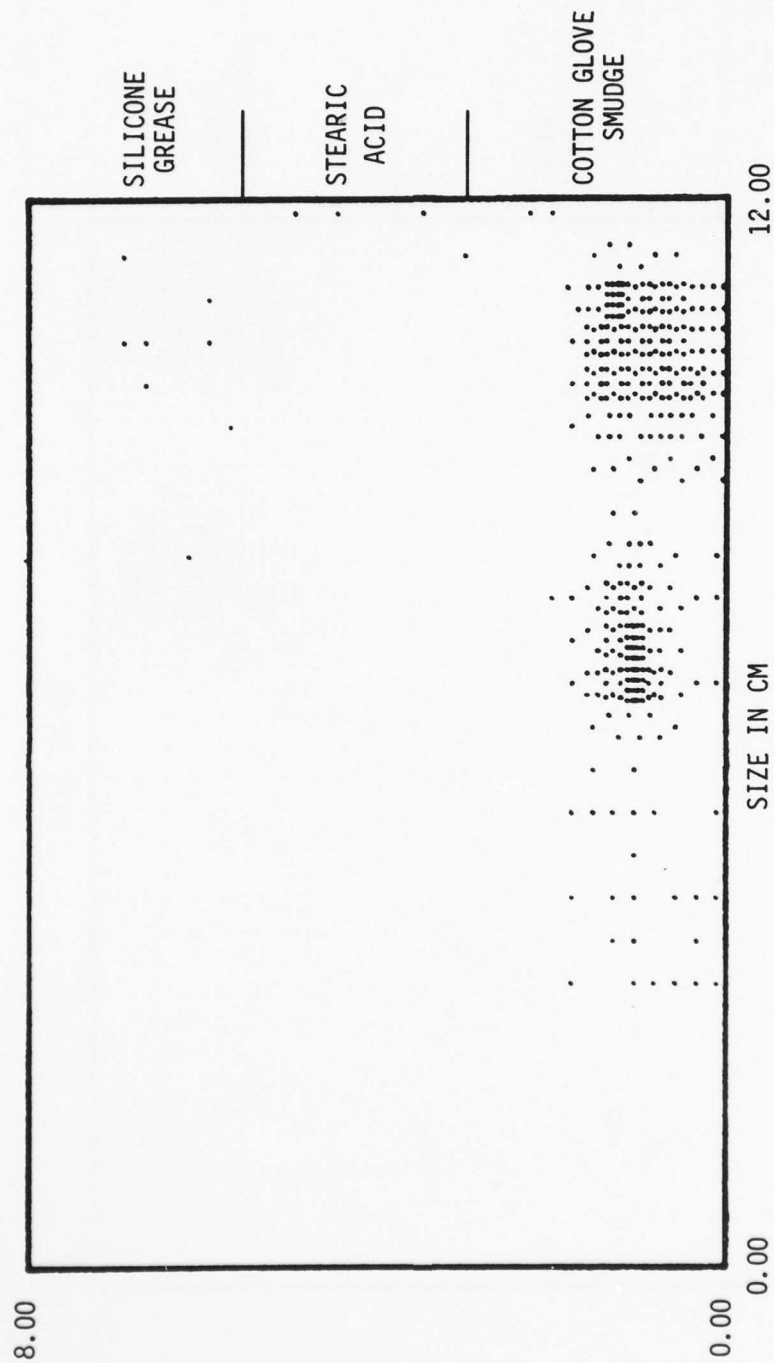
Fig. 35 Computer map using the automated ellipsometric ψ map of the convex side.

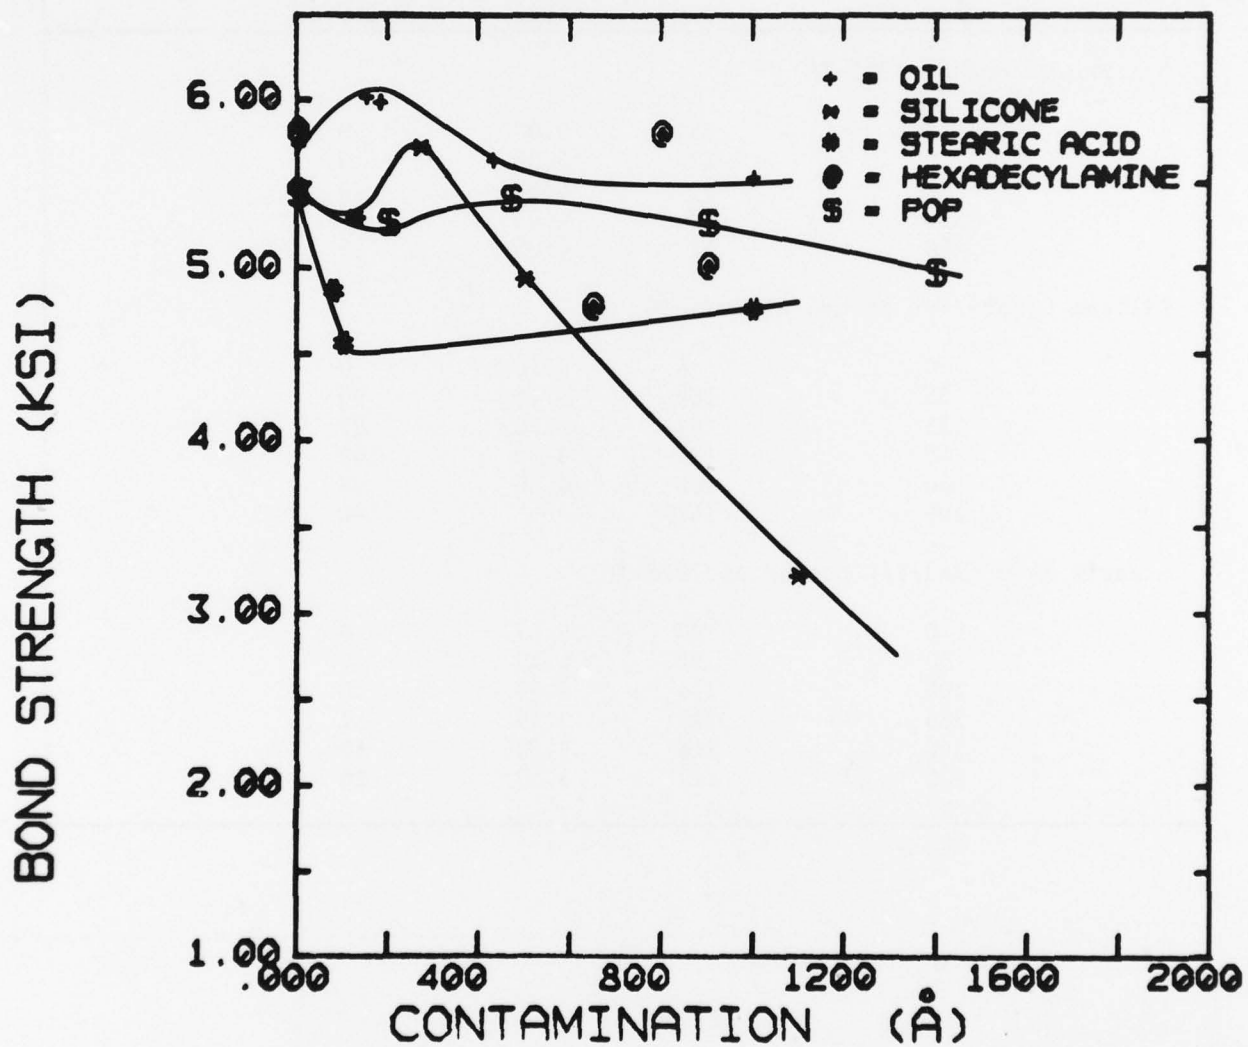
Fig. 36 Bond strength vs contamination for PAA AL 7075-T6.

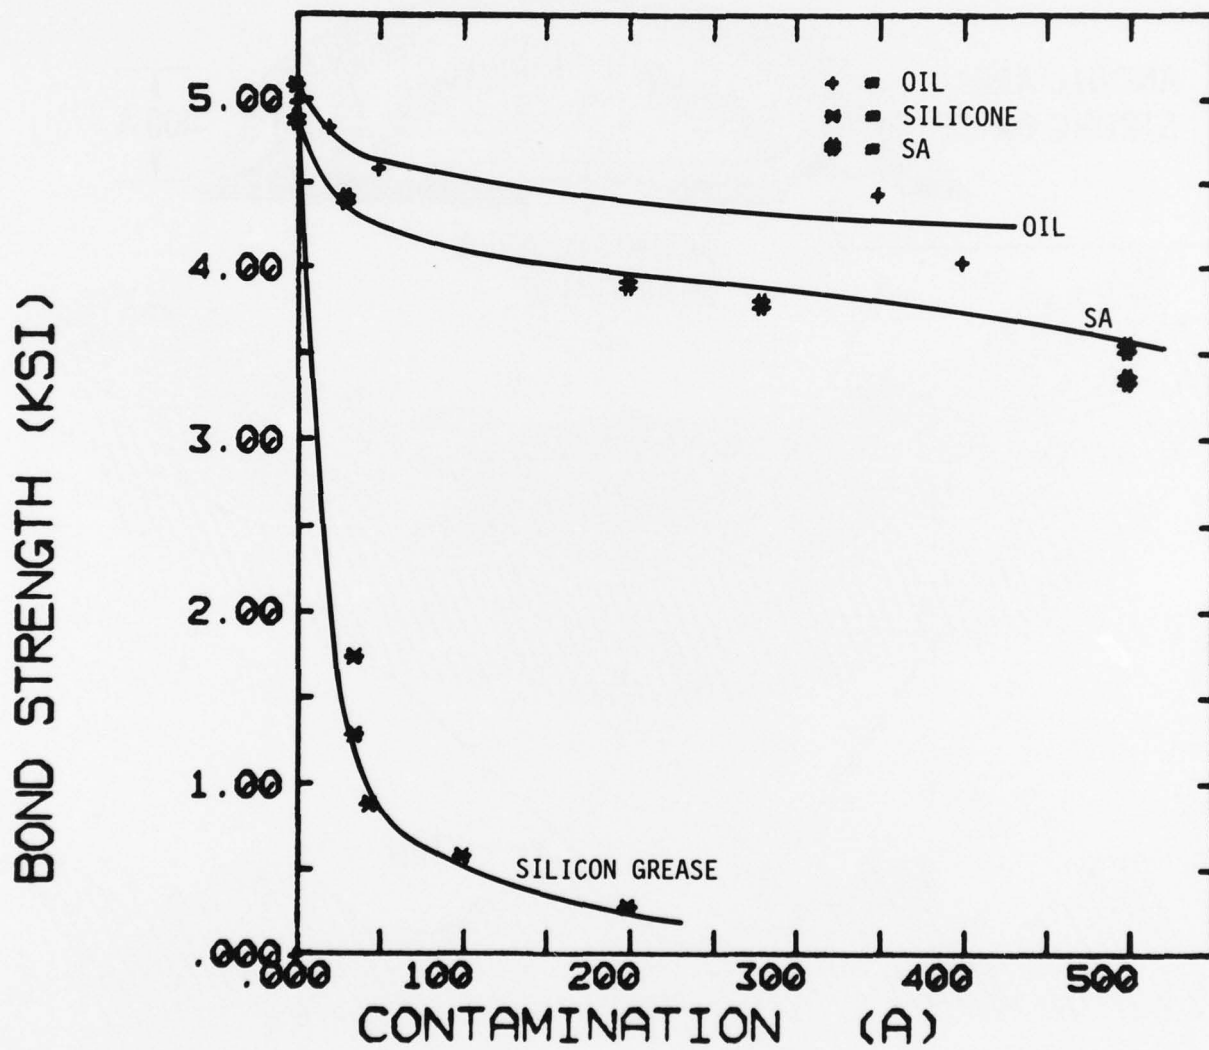
Fig. 37 Bond strength vs contamination for FPL etched AL 7075-T6.

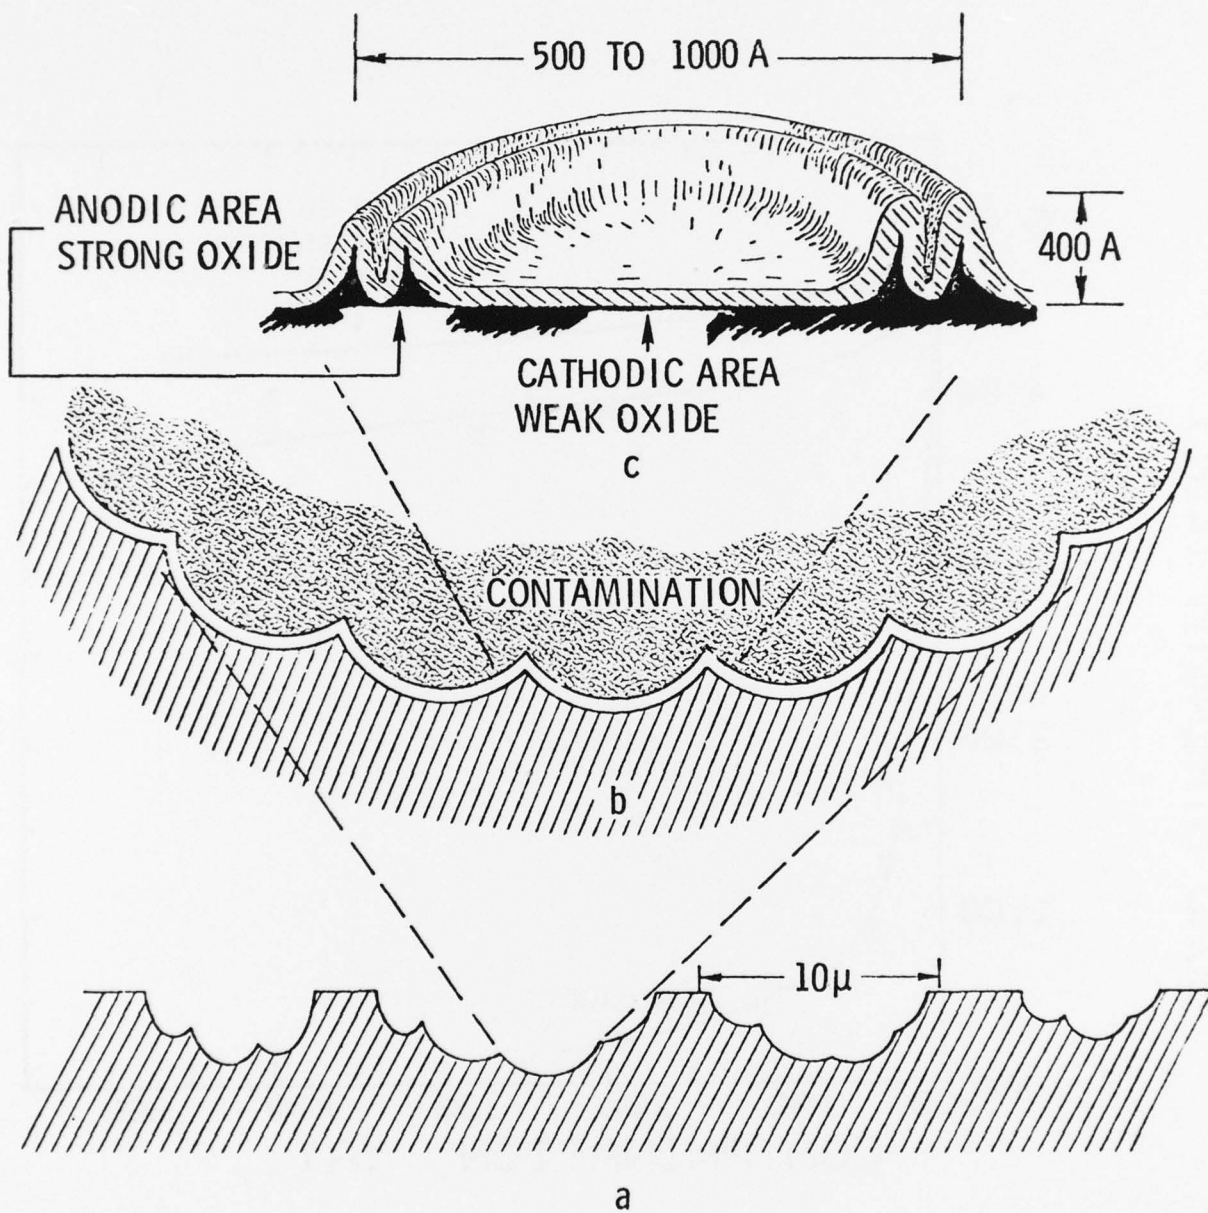
Fig. 38 Schematic representation of FPL etched aluminum with contamination, three magnifications.
